Phajoding Monastery Conservation Project

Division for Conservation of Heritage Sites Department of Culture Ministry of Home and Cultural Affairs

Location: Phajoding, Thimphu

The following is a brief report of the structural conditions of the three main Lhakhangs and the current work status at the site.

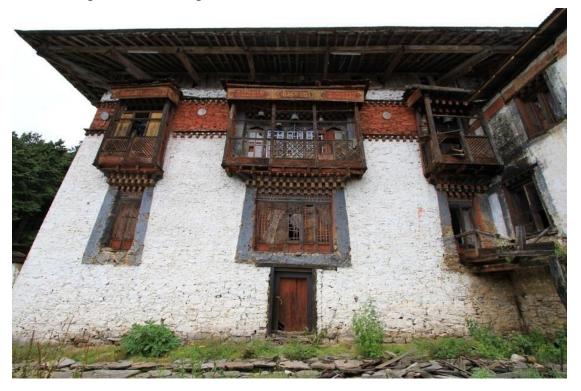
Fig1: Wogmin Lhakhang before the renovation works.

- Built by the 16<sup>th</sup> *Je-Khenpo* Sherub Singye (1784-91)
- Extended to its present size by the 21<sup>st</sup> Je-Khenpo Jam Drakpa.
- Three-storied structure built of stonewalls.
- Lack of timely maintenance has caused structural deterioration and the 2011 earthquake has aggravated the structural damages.

- Timber members of the rabsey, doors and windows are severely weathered and needs to be replaced. The structural timber members like the kachens, joists and lintels have also deteriorated and needs to be replaced.
- Zhali floor damaged.
- Plastering eroded.
- Cracks have developed on the walls and needs to be consolidated.

The replacement of the front three rabseys, the timber joists on the ground floor and first floor have been completed. Currently, the consolidation of the side walls and the inner structural walls are in progress whilst the consolidation of the roof structure is still to be carried out.

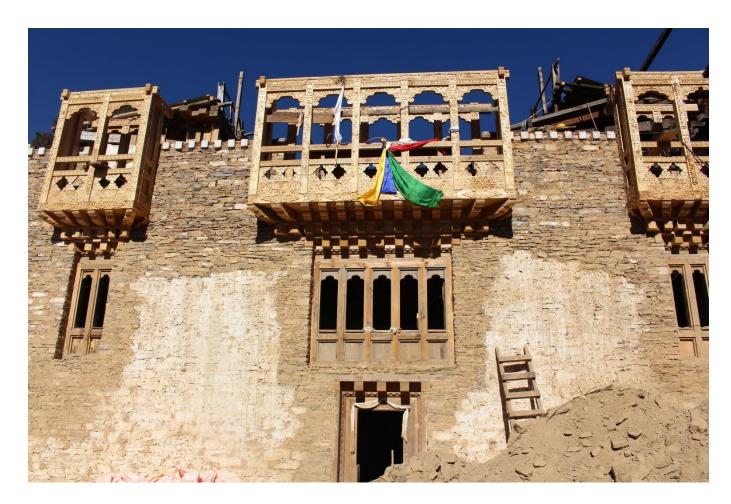
Fig 2: Renovation works on Wogmin Lhakhang in progress.

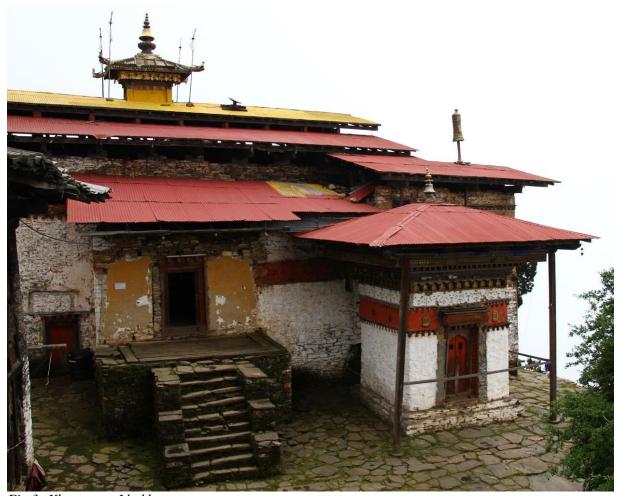
Fig 3: Khangzang Lhakhang

- Timber members of the rabsey, doors and windows are severely weathered and damaged.
- The walls at the entrance side have started to bulge and needs to be consolidated.
- Leakage in the roof of the Guru Lhakhang.

The renovation works on the Khangzang Lhakhang are scheduled to commence from February 2017.

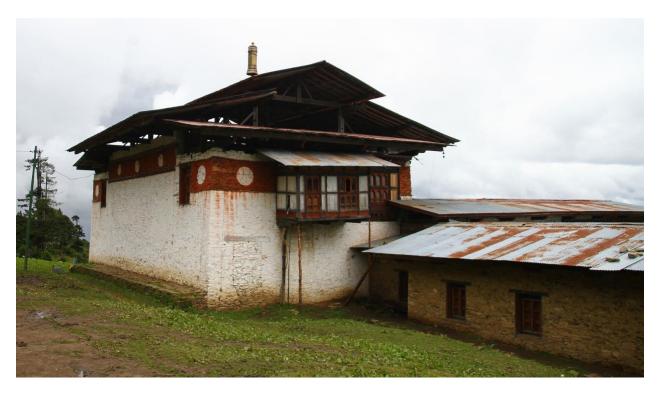
Fig 4: Jampa Lhakhang

- Timber members of the rabsey, doors and windows are severely weathered and damaged.
- The structural timber members like the kachens also needs to be replaced.
- The rear wall has bulged towards the inner part of the Lhakhang.
- Major structural cracks are visible on the inner structural walls.
- Leakage of the roof.

• The renovation works of the Jampa Lhakhang is scheduled to commence from August 2017.
